Operation and Maintenance of the Hydro-Jet™ Screen at 6 Sites in South Wales

Mr. Andrew Swift* and Dr Robert Y. G. Andoh**

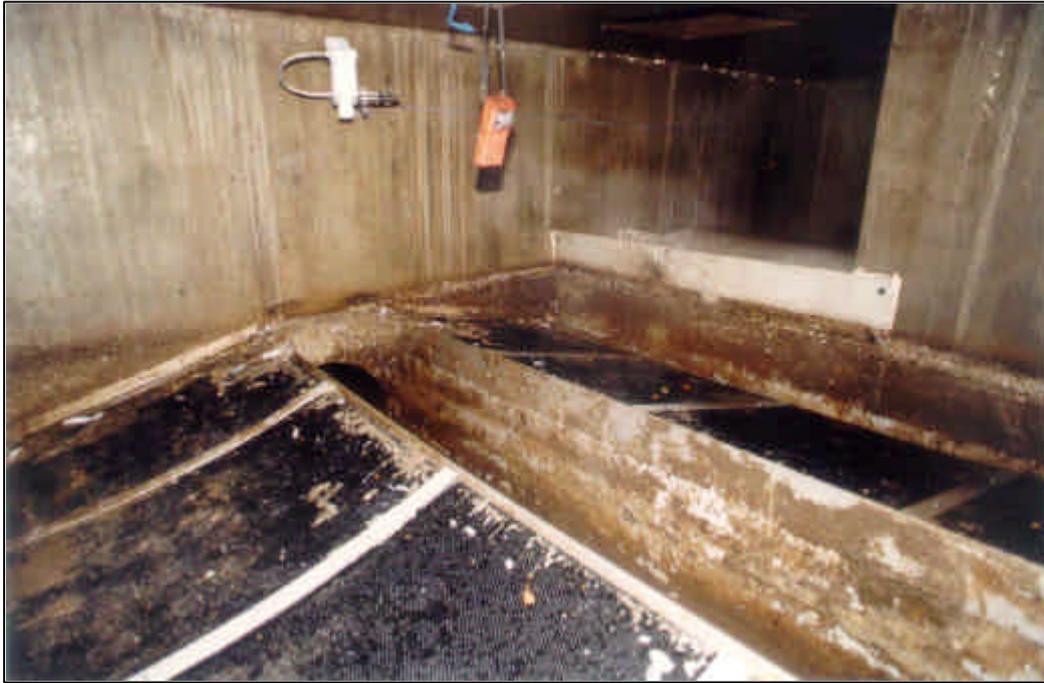
This unit performed well with the screen panels being clear on all but one occasion (See Plate 2). Maintenance was required only when the 217mm diameter orifice plate flow control on the continuation sewer became blocked with a combination of a broken umbrella and rags. No discharge of unscreened sewage to the watercourse was observed at the time of inspection with dry weather flow sewage being returned to the downstream sewer via the screenings return Hydro-Brake® Flow Controls.

Plate 2. Site 1 - Rhondda Valley, 19th December 2000 showing typical state of screen after operation (emergency overflow weir and siphon visible to the rear of the picture).

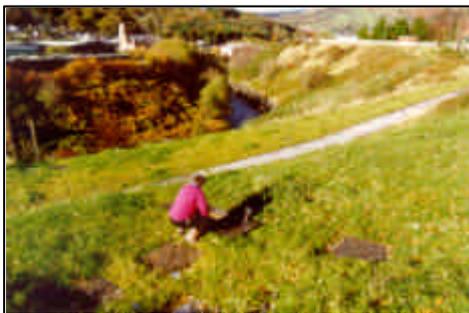
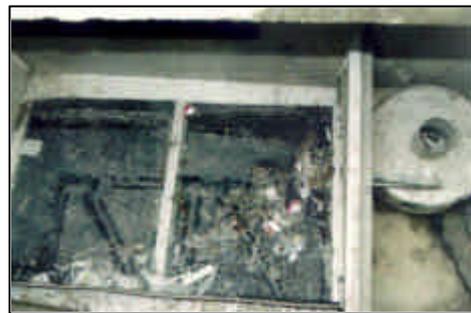
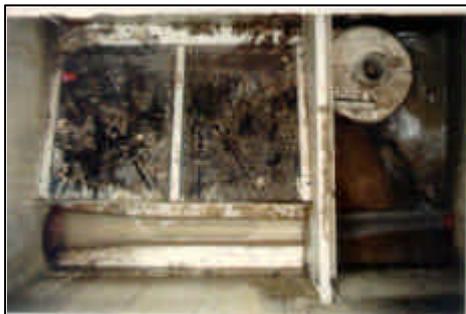
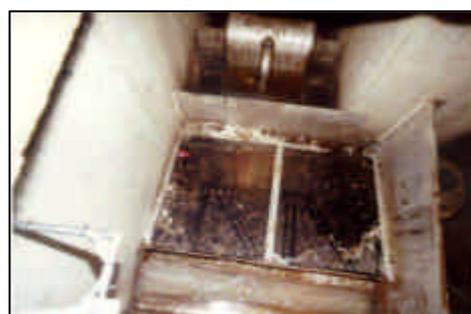
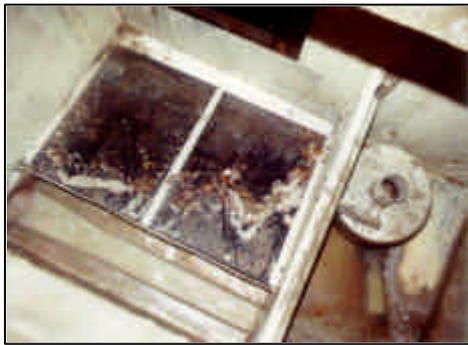
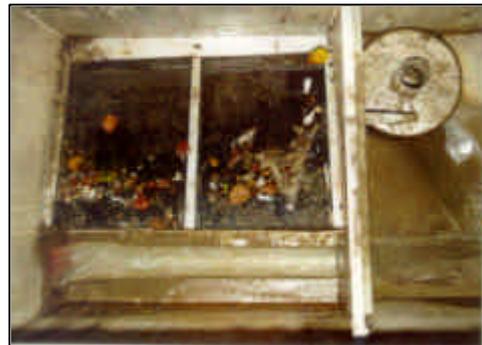
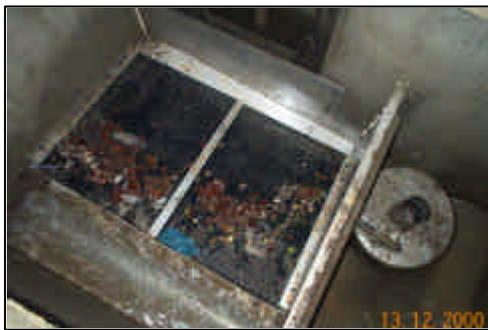
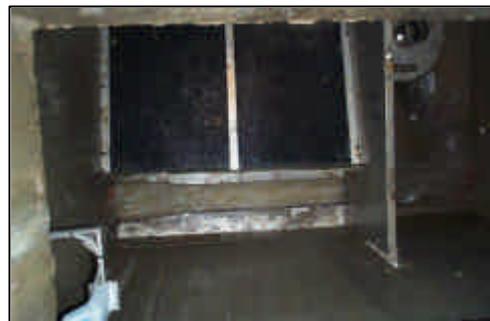
This unit, with a peak screening capacity of 100l/s is the smallest of the 6 monitored. The screen condition varied between 70% clear and 95% as the attached sequence of photographs illustrates. No maintenance of any sort was required during the monitoring period.

From the frequent visual inspections it is clear that the unit is performing well and has not experienced any blinding or blockages. The pattern of debris and state of the mesh panels show that no long-term accumulation of material is occurring with debris left over being cleared by subsequent events.

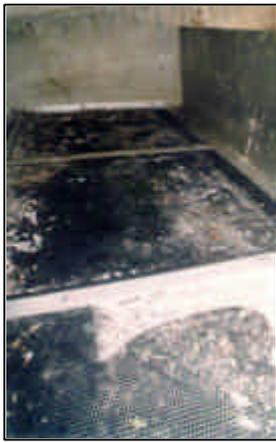
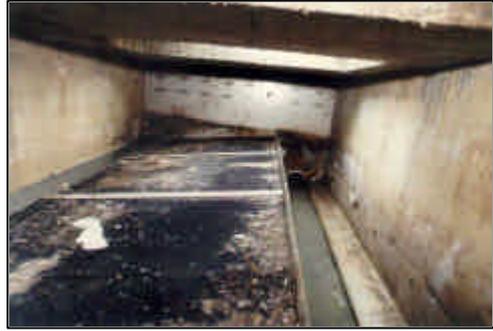
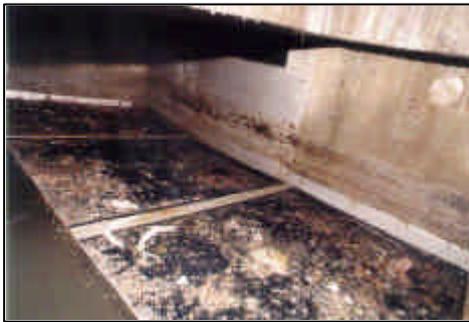
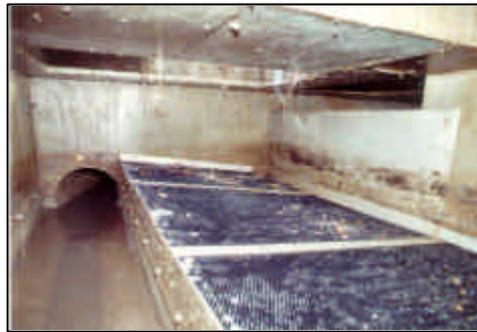
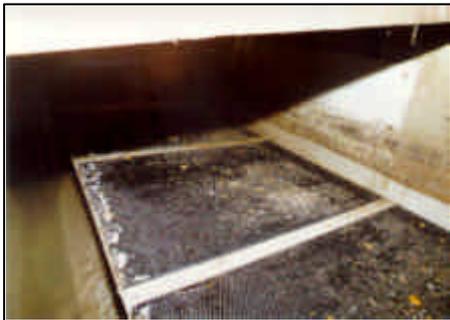
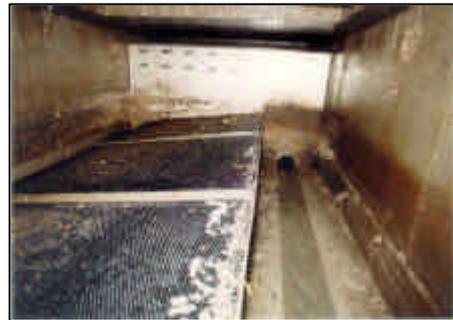
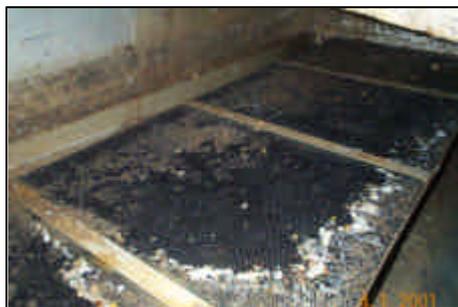
In common with the two other sites in the Rhondda Valley, this site has been visited 13 times over the 7-month period. No maintenance whatsoever has been carried out on the unit, which is reported to have performed well. The screen has varied between c. ~ 60% clear and 90% clear. Despite the pass-forward flow control having a 159mm aperture, there have been no reported blockages.

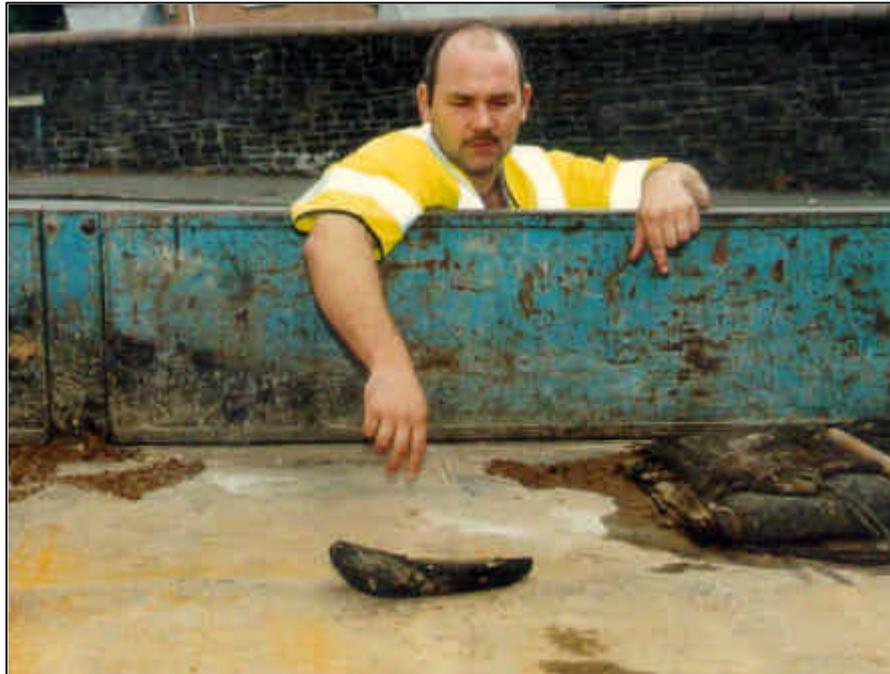
Over 7 months of operation with site visits on a monthly basis by both the maintenance gangs and Hydro, the screen has required maintenance only on two occasions following blockages of the flow control. The cause of one of these blockages is shown in Plate 3. When cleared it was found to be caused by a lump of tarmac. A 184 mm Hydro-Brake® Flow Control was used in preference to the equivalent orifice plate which was only 115mm in diameter, due to the likelihood of the orifice plate blocking more frequently.

Plate 3. Showing cause of blockage to flow control (Site 4, Cynon Valley).

Though Hydro-Brake® Flow Controls offer a way of maintaining a clear opening of typically 400 – 600% larger than the equivalent orifice or penstock, the fact that they are larger does not make them entirely immune from blockages (e.g. see Plate 3 showing the removal of a lump of road tarmac). The larger the opening is however the fewer blockages there will be.

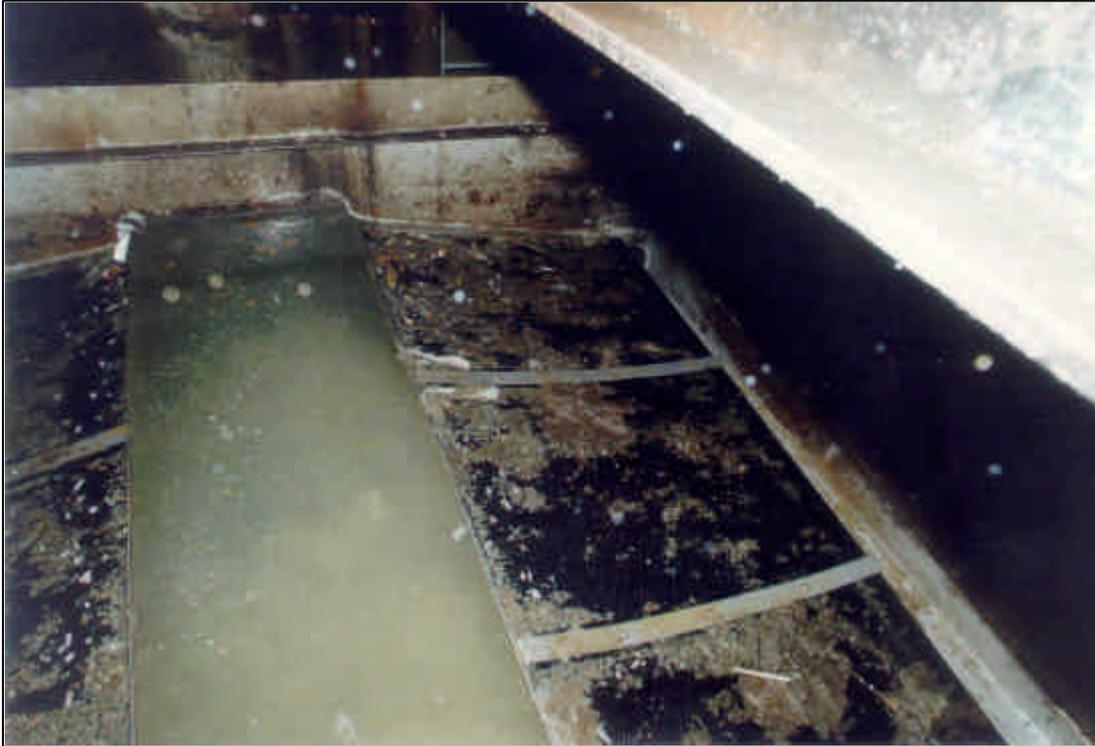
This blockage had resulted in flow passing over the screens and on to the continuation flow sewer via the screenings return Hydro-Brake® Flow Controls. During normal conditions this type of blockage does not result in a spill of unscreened sewage to the watercourse. This was the case during a visit on 25th September 2000 as illustrated in Plate 4.

A combination of sticks and rags had caused a partial blockage however the screens had remained at least 50% clear. This obstruction was cleared with a pole during the visit and the water level dropped back to normal dry weather flow conditions. This feature represents a significant advantage of the Hydro-Jet Screen™ over other screening screens. With other screening systems, if the main continuation flow control blocks, there is inevitably a spill to the receiving water course whereas with the Hydro-Jet Screen™ the screenings return Hydro-Brake® Flow Controls allow dry weather flow to be returned to the continuation flow preventing a continuous spill and allowing time for maintenance.

Plate 4. High level in dry weather flow channel due to partial obstruction of flow control (25th September 2000).

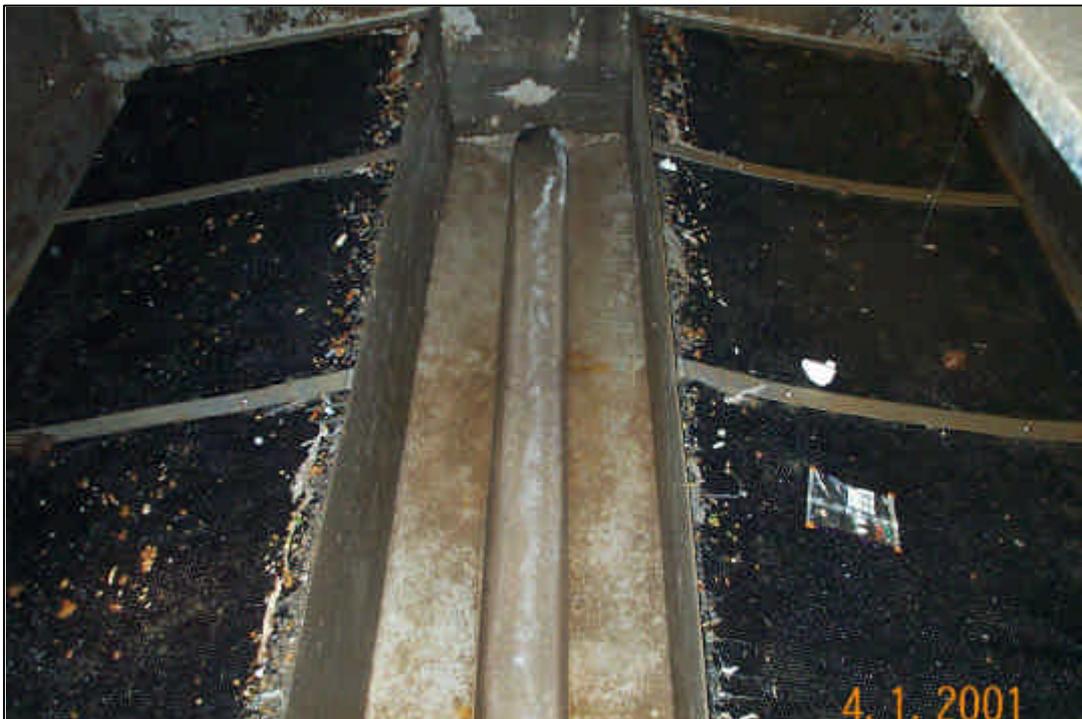
Plate 5. Typical view on inspection, 4th January 2001 with low flows passing through the dry weather flow channel and evidence of some debris left on screen from previous spill event.

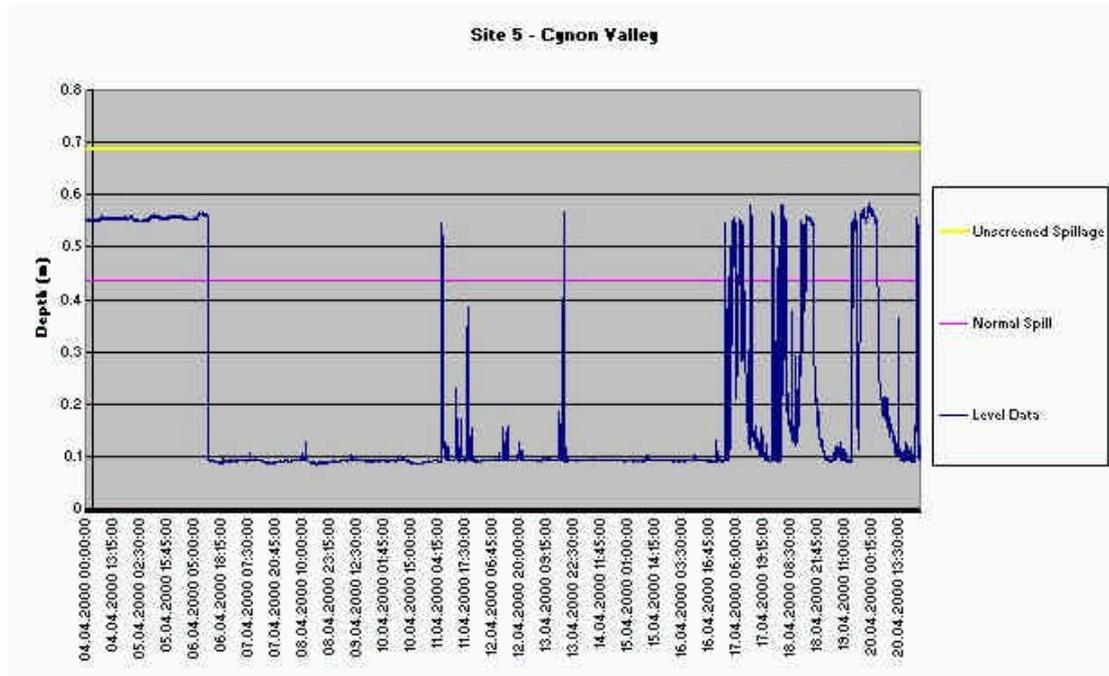
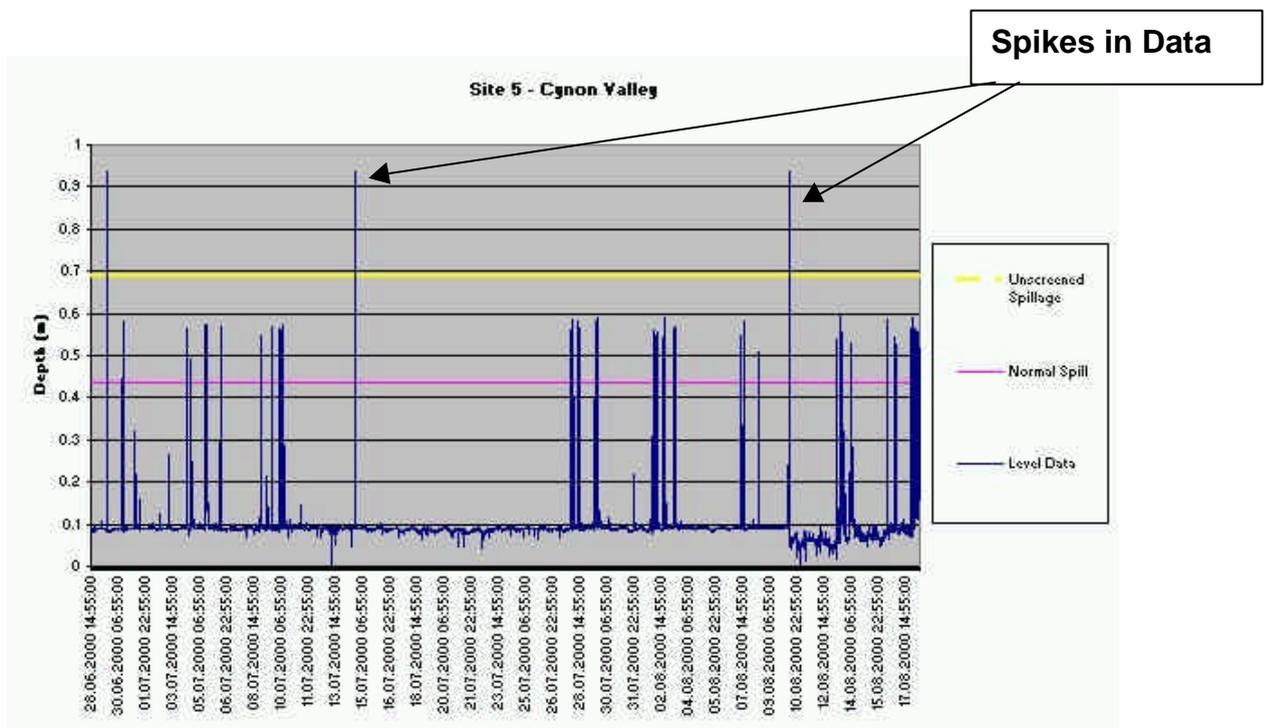
Figure 2 Telemetry Data for Site 5 in Cynon Valley

Figure 3 Telemetry Data for Site 5 in Cynon Valley showing examples of spikes in the "Raw Telemetry Data"

Examples of the initial telemetry data obtained in the raw unprocessed form are shown in Figures 2 & 3. This contains some spurious spikes (which is to be expected from raw unprocessed data) as shown in Figure 3. Data acquisition was at 5-minute intervals and water levels at a CSO installation is unlikely to rise above the emergency overflow level and fall to dry weather flow levels in a period of 5 minutes. However as can be seen in Figures 2 & 3, the output from telemetry monitoring is useful in identifying spill events in response to rainfall and ascertaining whether or not water levels have risen to the emergency overflow level over a long duration causing a sustained discharge of unscreened effluent to the watercourse.

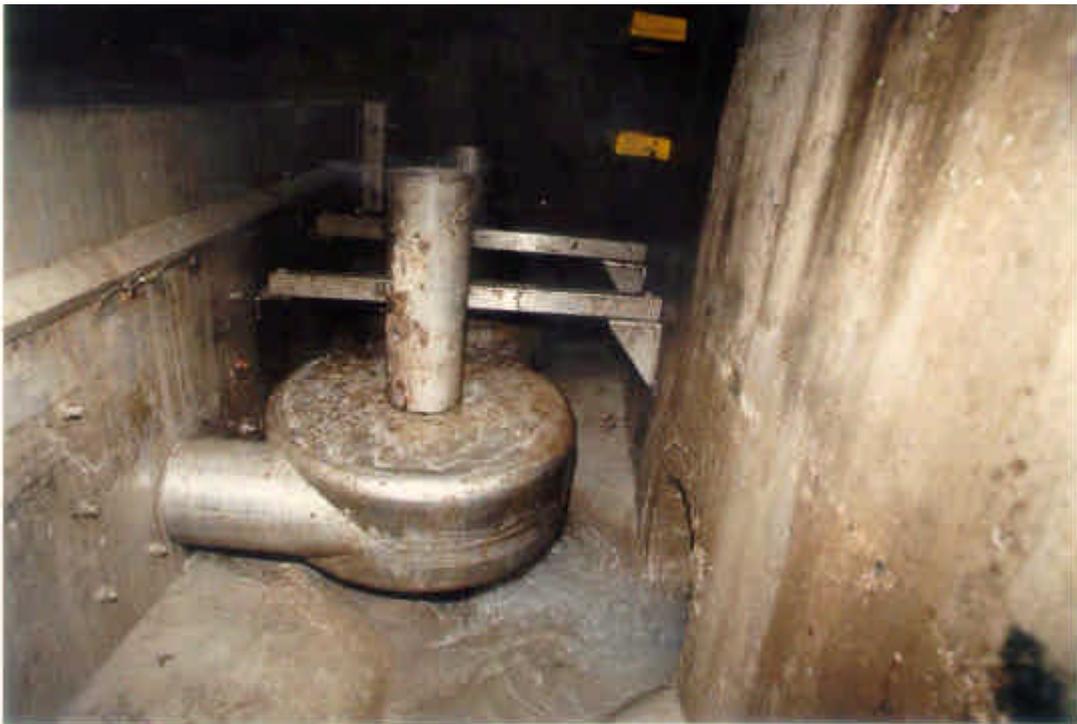
On four (4) of the seven (7) visits to this site the screen panels were clear however some blinding was noted on the other three (3) visits. The Sewage Maintenance Contractor has subsequently reported that the downstream sewer had been blocked on several occasions at a local building site with shuttering bricks and rubble removed. This would result in a backing up of the sewer to the overflow, which would operate and ultimately lead to blinding of the screen if the screenings could not be passed on downstream. There was evidence of downstream surcharging of the system on all of our monthly visits, indicated by tidemarks in the screenings return chamber (Plate 6).

Plate 6. Photograph showing evidence of downstream surcharging of the flow controls.
