Magic or Myth?

Exploring the Facets of a Novel Electronic Surveying Technique

Case Study – Flushing, Cornwall

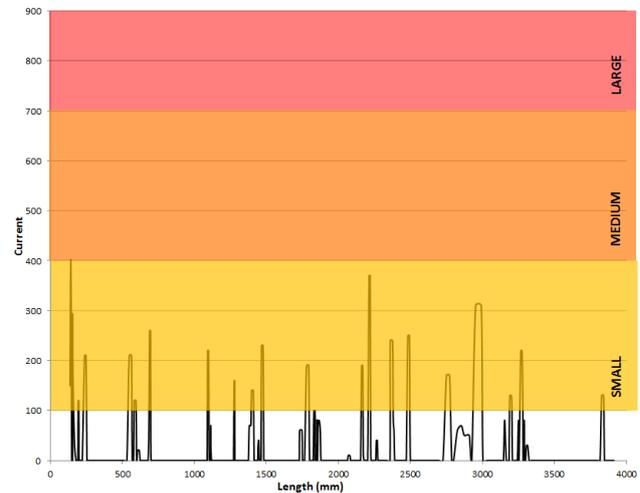
Figure 3: Flushing CCTV Survey Report and Electronic Survey Report for the same length of sewer

Date: 15/01/2013		Job number: ERN10422		Weather: no rain or snow		Operator: GR		Section number: 4		PLR: SW80338726 X	
Flow Control: No flow control		Vehicle: HJ60		Camera: AMI		Preset:		Cleaned: no		IPID: 10059134	
Flushing, Cornwall		Type: Gravity drain/sewer		U/S MH: SW80338726		U/S Depth:		D/S MH: SW80338714		D/S Depth:	
Road: Pitick Terrace		Catchment: Media number:		U/S MH: SW80338726		U/S Depth:		D/S MH: SW80338714		D/S Depth:	
Location details: Road		Inspection: SW80338714 (U/S) SW80338726		Use: Combined		Total Length: 4.00 m		Purpose: Investigation of infiltration problems		Pipe shape: Circular	
Inspection: SW80338714 (U/S) SW80338726		Vehicle: HJ60		Camera: AMI		Preset:		Cleaned: no		IPID: 10059134	
Use: Combined		Total Length: 4.00 m		Purpose: Investigation of infiltration problems		Pipe shape: Circular		Pipe size mm: 150 mm		Pipe material: Pitch Fibre

Comment:		1:50		Position		Code		Observation		MPEG Photo Grade	
SW80338714		0.00		MH		Start node type, manhole, reference number: SW80338714		00:00:00		(Const) 0

0.00		REM		General remark		Remarks: survey starts in channel of MH		00:00:00		SW80338726 (Misc) 0	
0.01		REM		General remark		Remarks: VC Rocker Pipe		00:00:00		X_U_1501201_3_172311_2_A.jpg (Misc) 0

0.40		S01		DEG		Attached deposits, grease, from 7 to 5 o'clock, 5% cross-sectional area loss, Start		00:00:26		(Serv) 3	
0.75		MC		Material changes, pitch fibre		00:00:36		SW80338726 (Misc) 0		X_U_1501201_3_172311_5_A.jpg

3.70		REM		General remark		Remarks: Abandoned on debris in joint of rocker pipe just before manhole		00:02:19		(Misc) 0	
3.71		F01		DEG		Attached deposits, grease, from 7 to 5 o'clock, 5% cross-sectional area loss, End		00:01:48		(Serv) 3

3.71		MC		Material changes, vitrified clay		00:01:50		SW80338726 (Misc) 0		X_U_1501201_3_172311_8_A.jpg	
3.71		H		Hole in drain/sewer, from 11 to 12 o'clock		00:01:50		SW80338726 (Struct) 4		X_U_1501201_3_172311_9_A.jpg

3.71		BJ		Broken pipe at joint, from 1 to 11 o'clock		00:02:19		SW80338726 (Struct) 4		X_U_1501201_3_172311_10_A.jpg	
3.72		SA		Survey abandoned		Remarks: Unable to Pass Debris		00:02:19		(Misc) 0	
Structural Defects		Service Defects		Miscellaneous Features		STR no def		STR peak		STR mean	
1		80		20		80		4		1	
2		1.65		6.4		3

The Flushing Case Study recommended rehabilitation to 419m of sewer ranging between 100mmØ to 225mmØ at a total estimated cost of £178k.
