Condition Assessment of Sewage Rising Mains

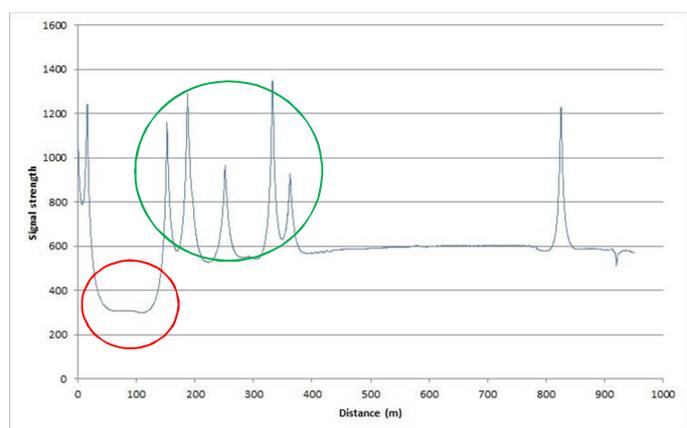
Case Study: 200 mm PVC Rising Main Inspection

The graph alongside shows the result from a survey of a live PVC rising main. The survey covered the full 950m length of the pipeline. The peaks (circled in green) correspond to metallic fittings and short sections of pipe used to repair previous bursts. The section circled in red had been replaced using HPPE pipe shortly before the inspection. The difference in the signal strength between the pipe types is clearly seen. The peaks at either end of the new section correspond to the metal fittings used to couple the replacement section of pipe to the original pipe.

By using the insulating properties of a plastic rising main pipe the electrical conductivity technique was developed to identify conductive pathways caused by a metallic fitting or a leak in the plastic main. The Sahara sensor head passes a small current into the main and the point of escape is monitoring to track the position of the leak or fitting on the rising main.
